PMDA

Medical Safety Information

Extra issue No. 3 March 2022

Reminder Series No. 3 (Precautions for Magnetic Resonance Imaging (MRI) Scans)

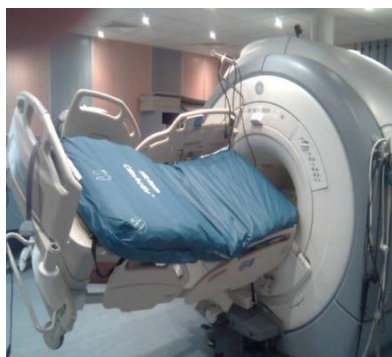
Bed

There have been reports of accidents where patients or healthcare professionals were injured by being hit by flying magnetic objects such as oxygen cylinders or stretchers.

Accidents involving magnetic objects (2)
